MJM Home Inspection Company, Inc.
159 West Westfield Avenue
Roselle Park, NJ 07204

William R. Eastmond Pavilion.

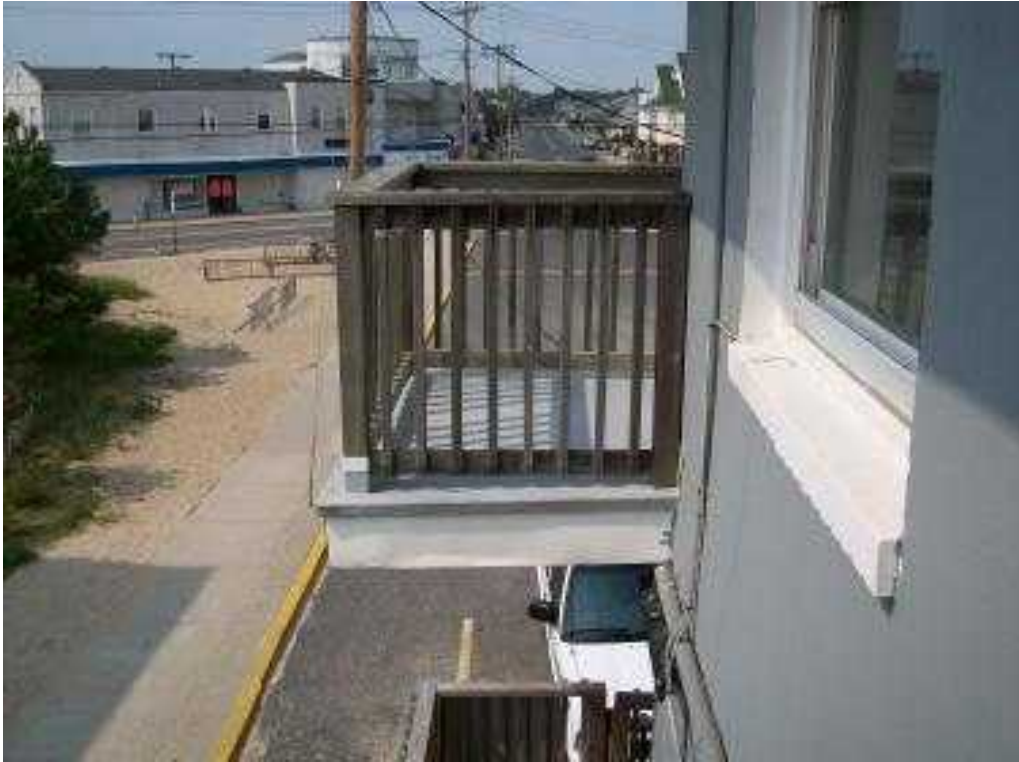
Balcony leaning due to non compliant framing system.

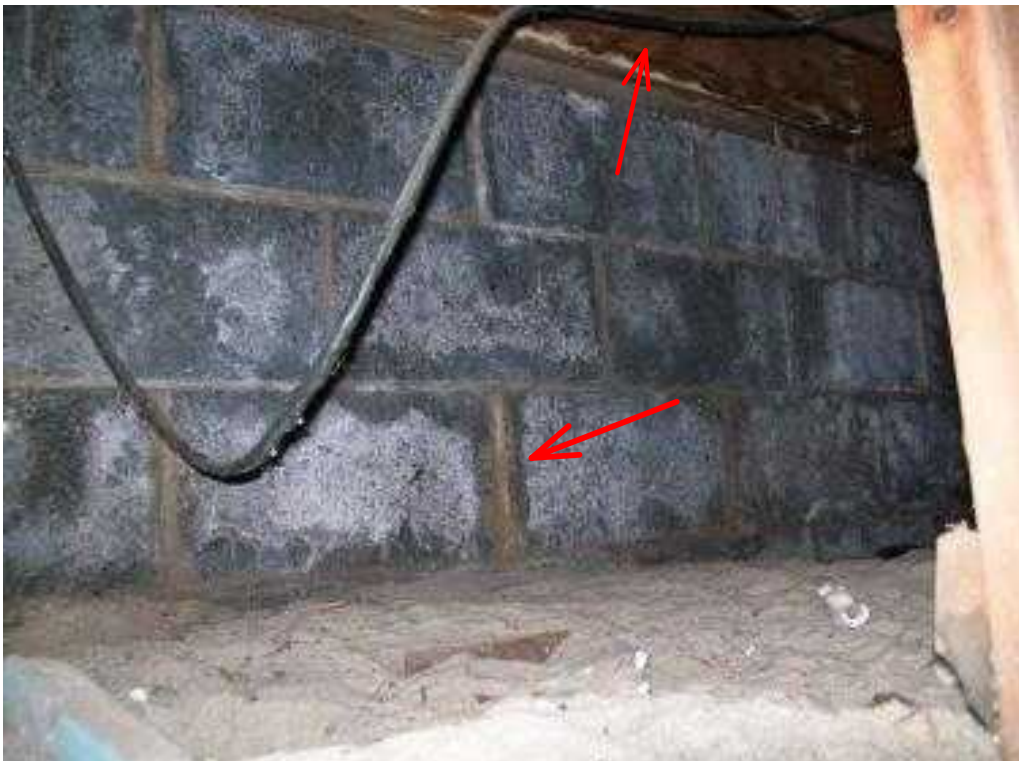
Continued moisture damage.

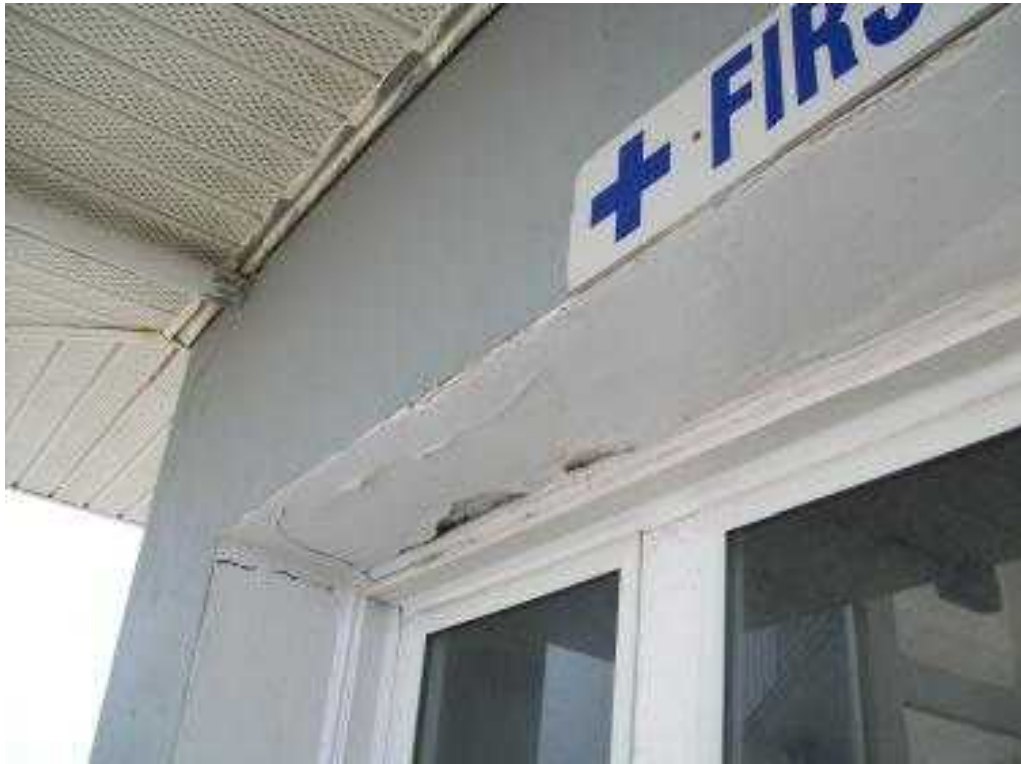
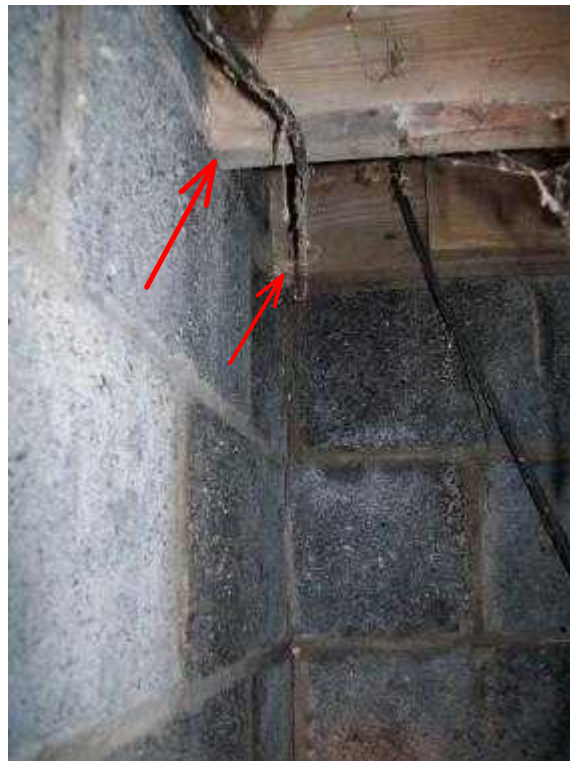
Floor beams damage at bearing points by moisture due to unconditioned space.

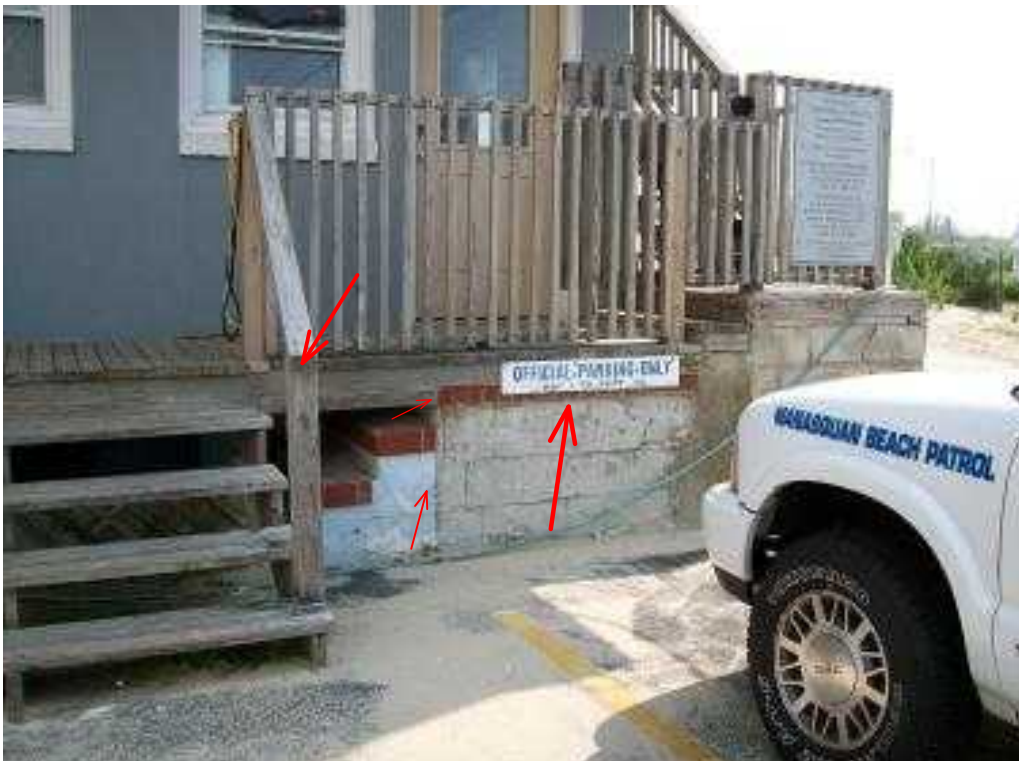
Handyman style deck construction not code compliant.

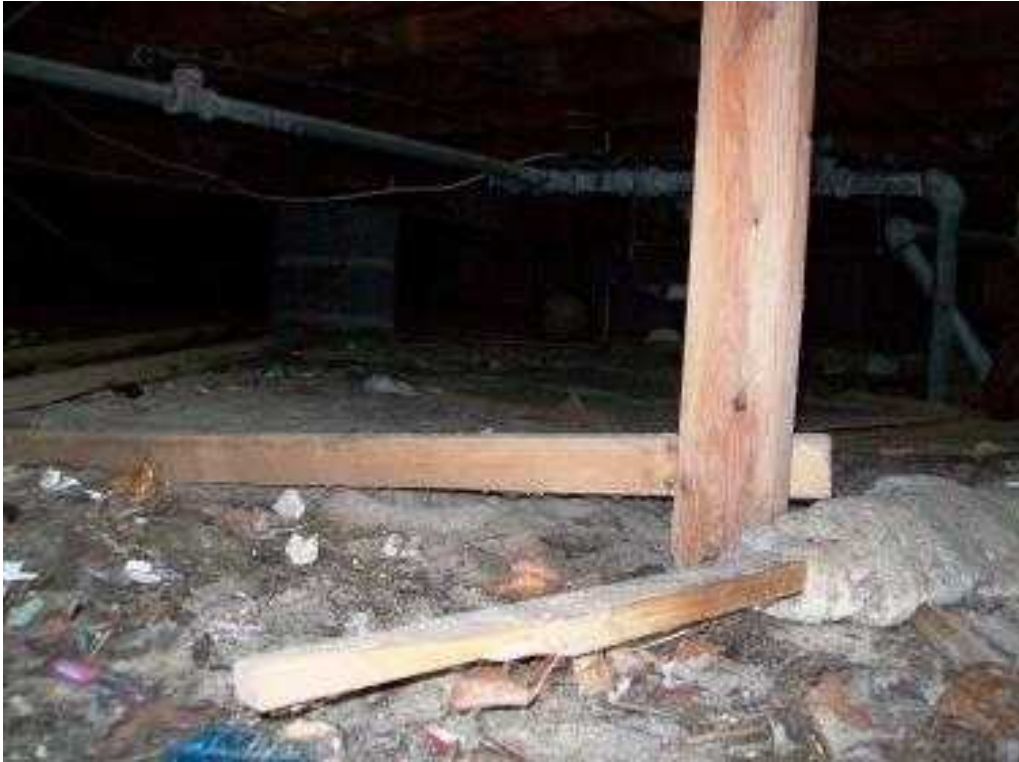
Galvanized water lines, outdated rust from interior of pipe slowing water pressure to the supply areas.

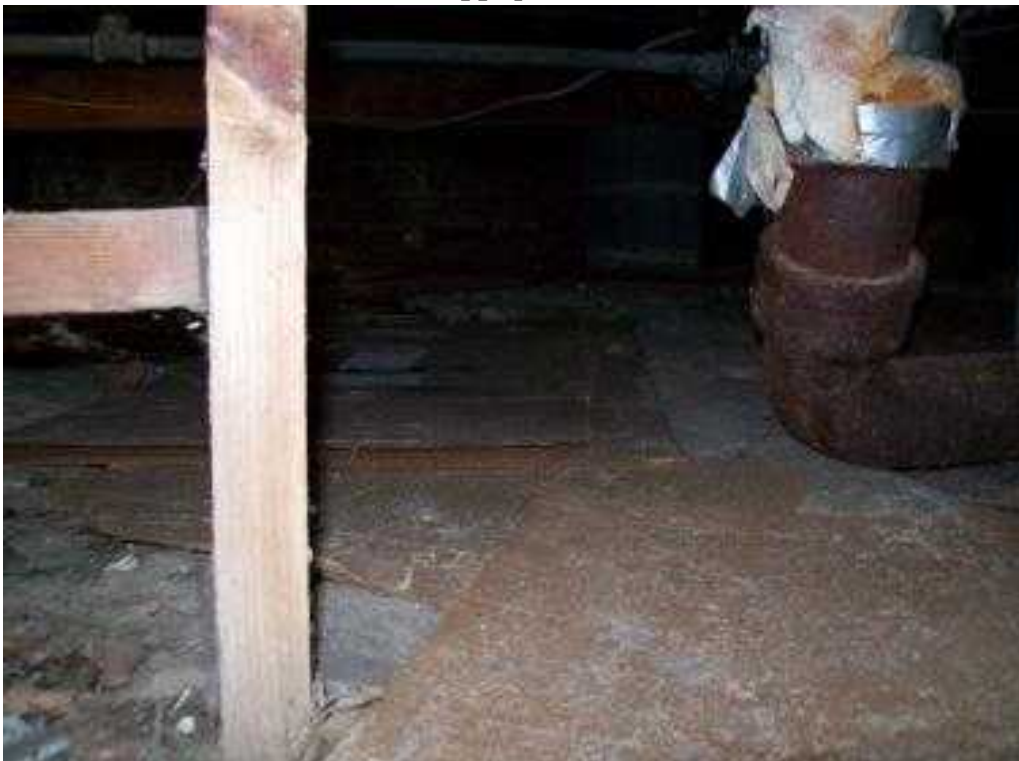
Damage plumbing with more temporary supporting.

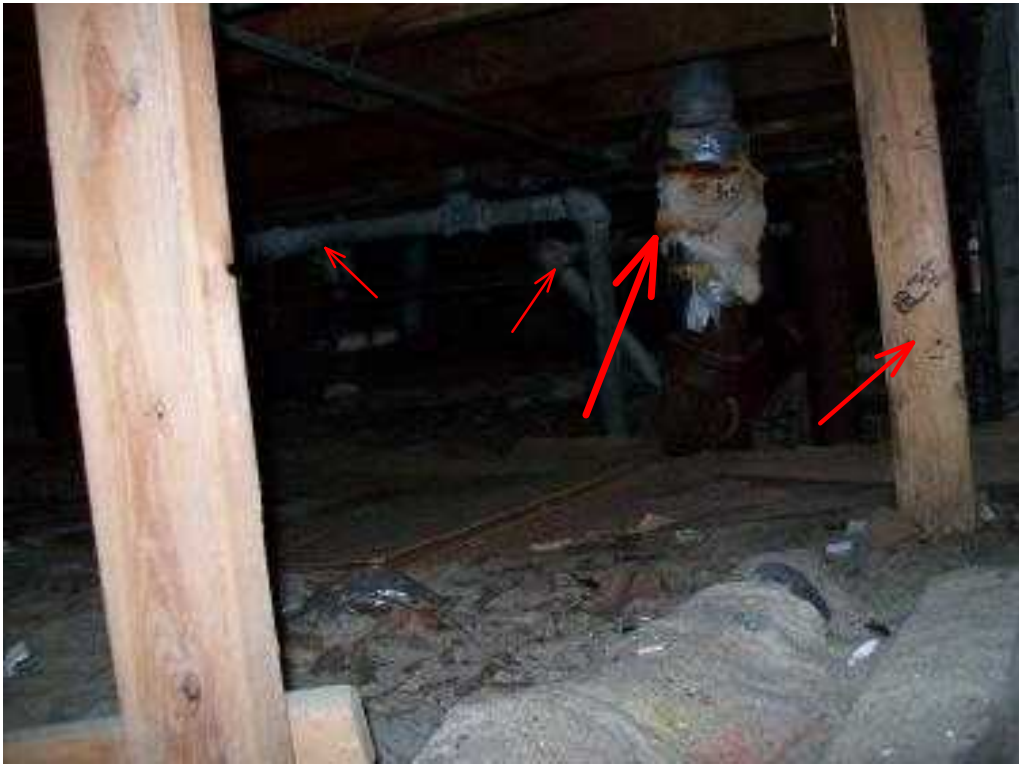
Continue moisture damage to components in crawl space. There many temporary supports in place.

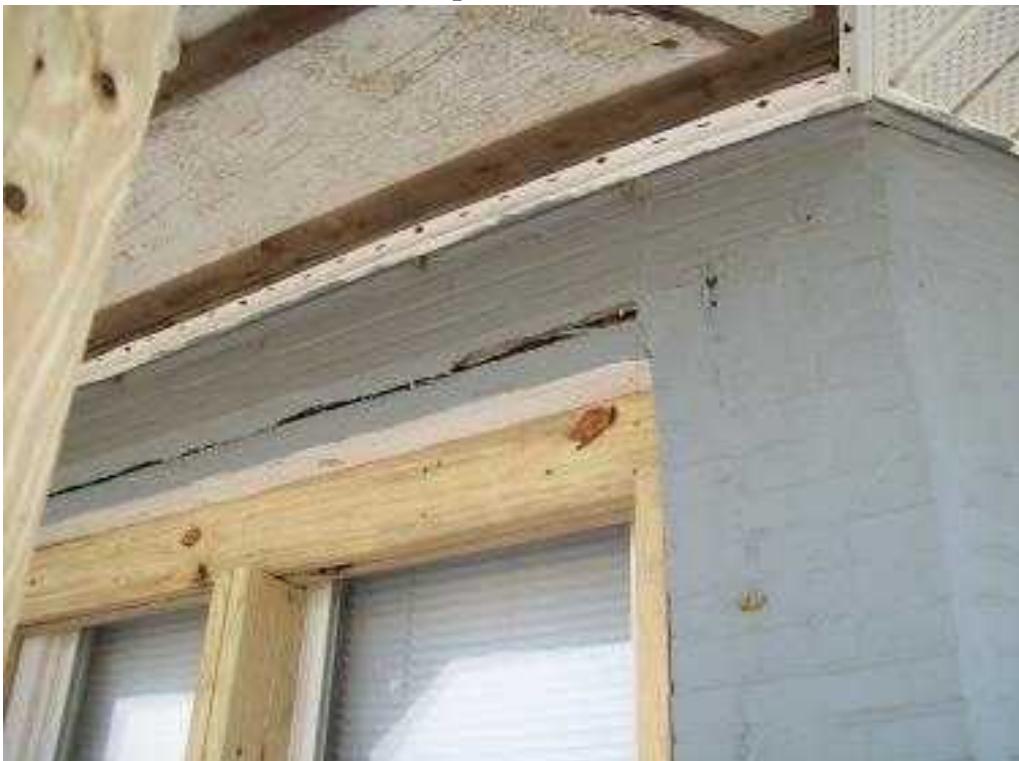
Dry rotted lintel system, requires replacement.

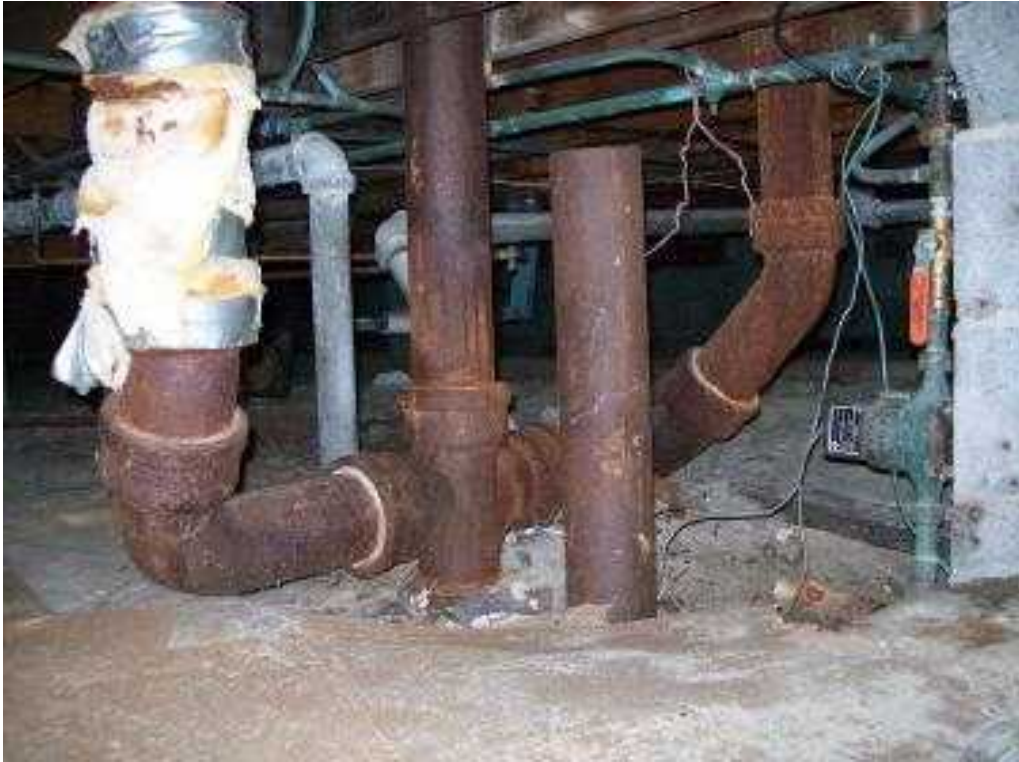
Out dated plumbing system all piping shows signs of moisture damage.

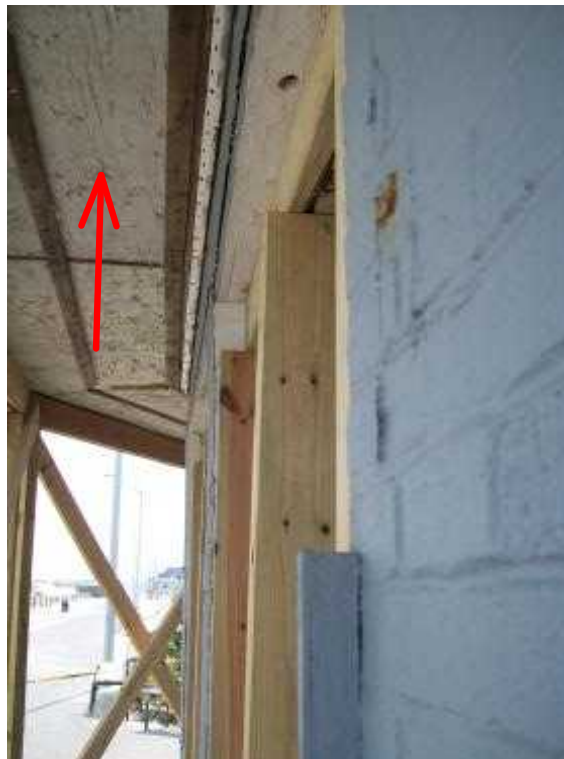
Unvented soffit moisture damage to plywood.

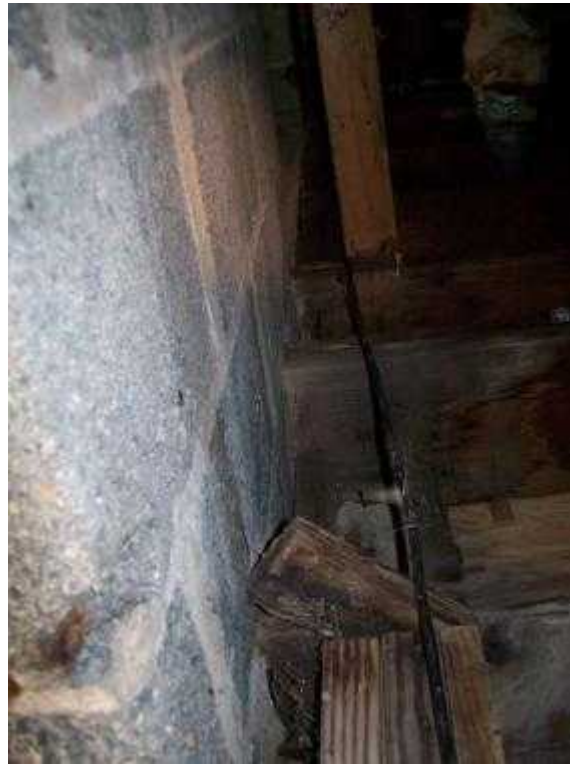
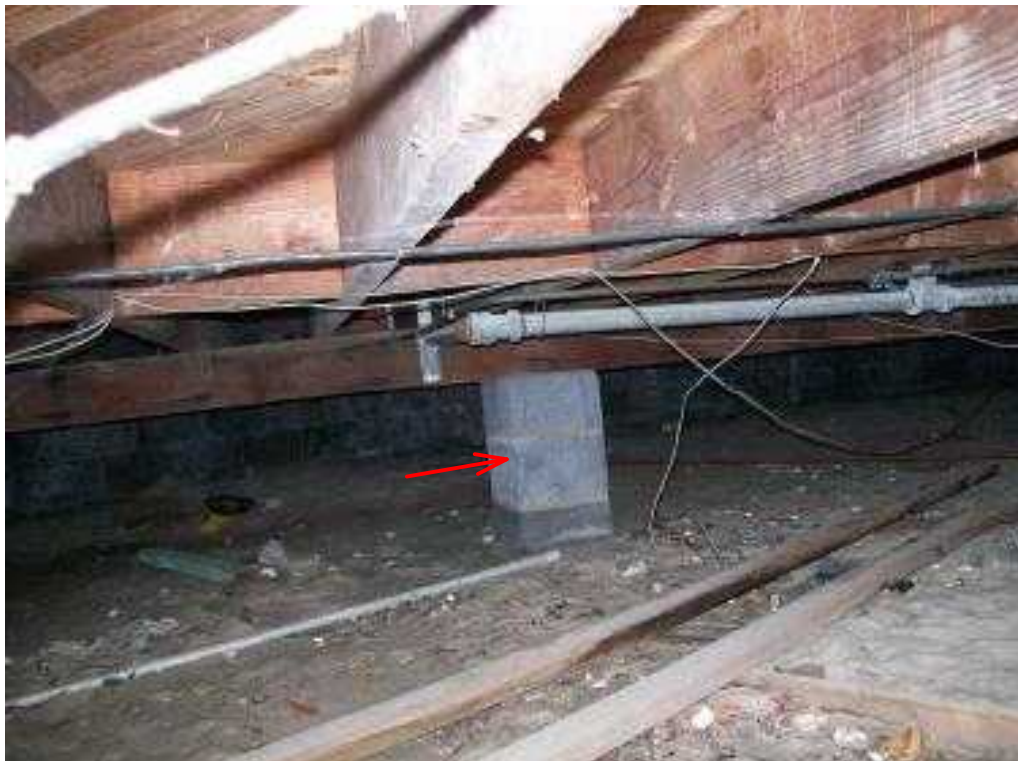
Single block pier for supporting main beam approximately 45 lf. Pie footings should be placed approximately every 72" center to center. Galvanized drain lines in an unconditioned space.

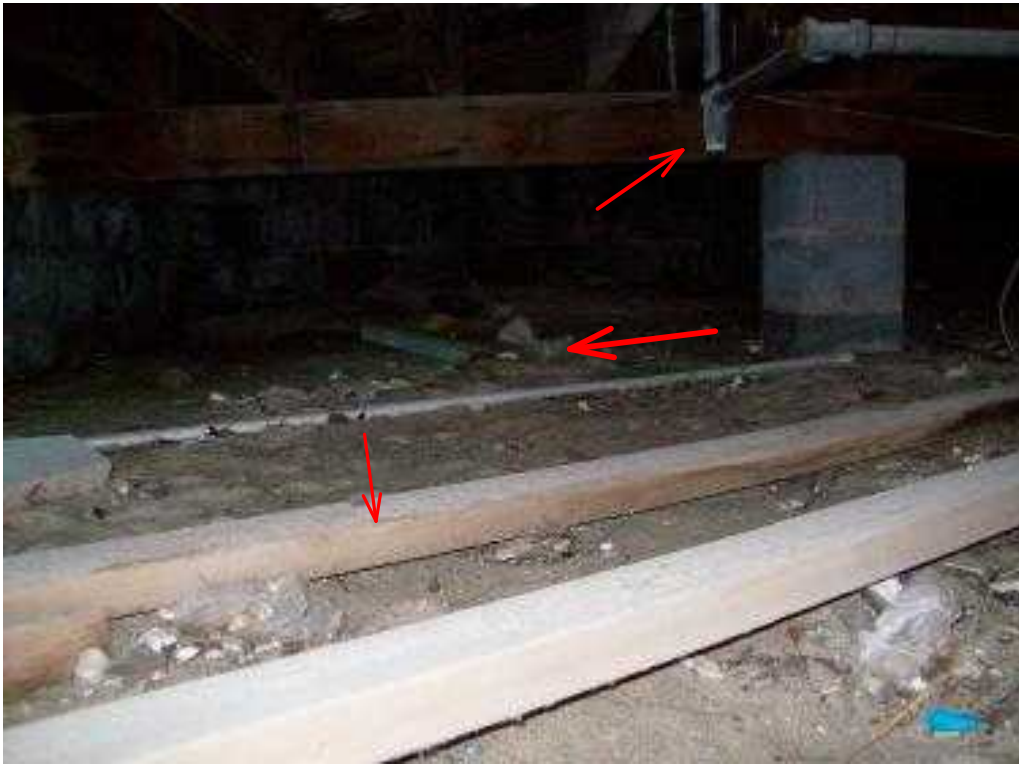
Foundation floor has no vapor barrier causing moisture damage to the floor beams, girder and piping systems

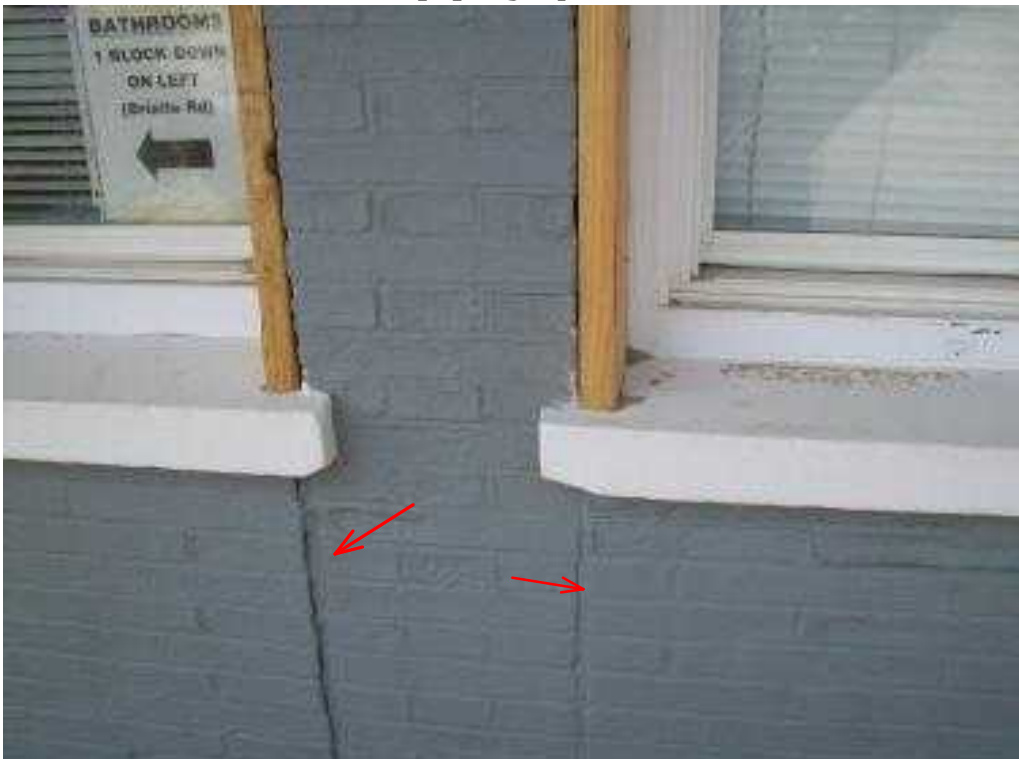
Wall fill in no expansion. The wall is moving outwards because there is no connection to the pier and expansion is not in place.

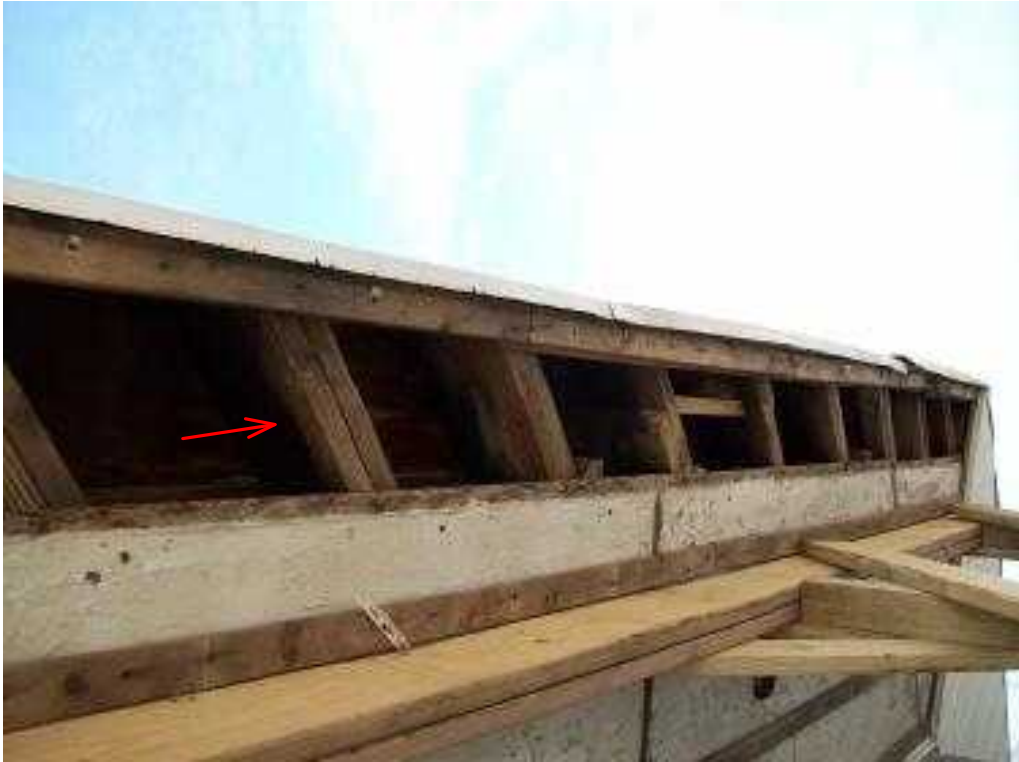
Undersized balcony framing and the beam projection into the building should be 3 x the length of the projection, existing condition does not meet this criteria.

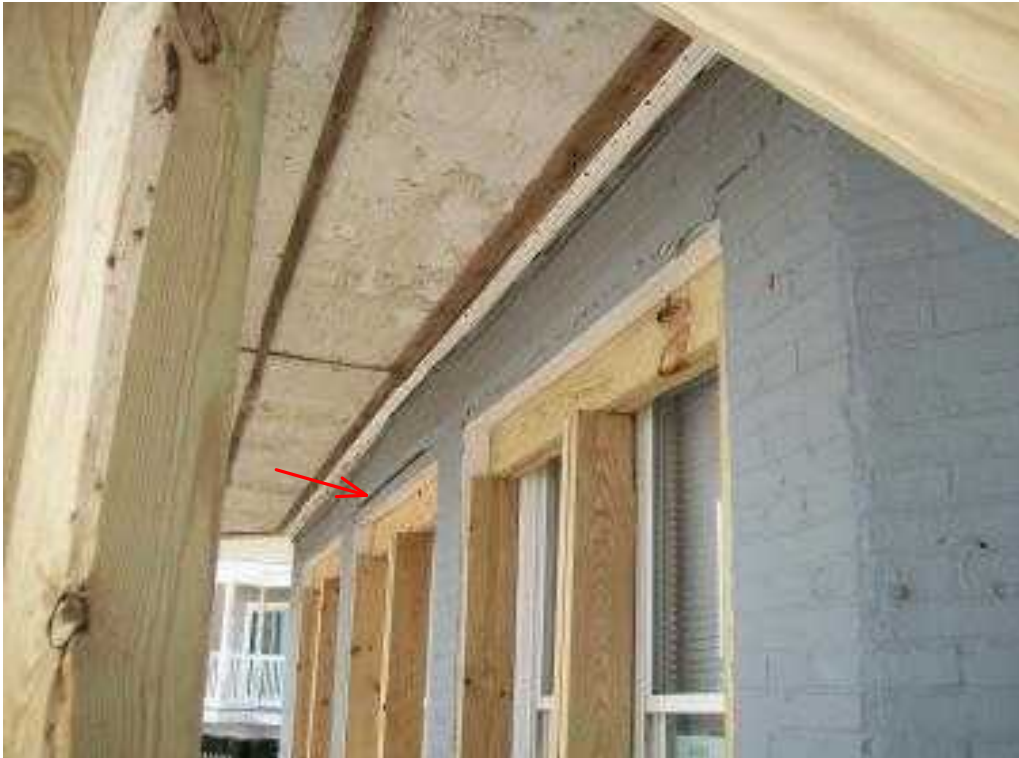
All lintel supports dry rotted require replacement.

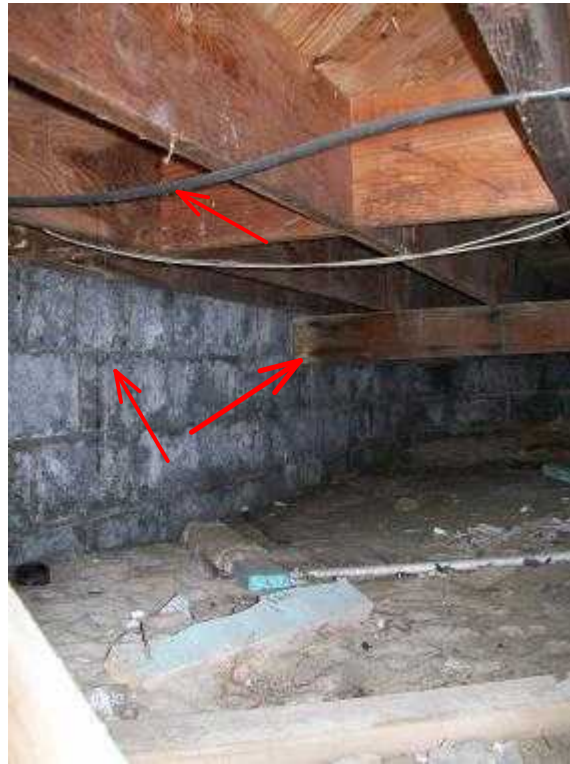
Additional moisture damage.

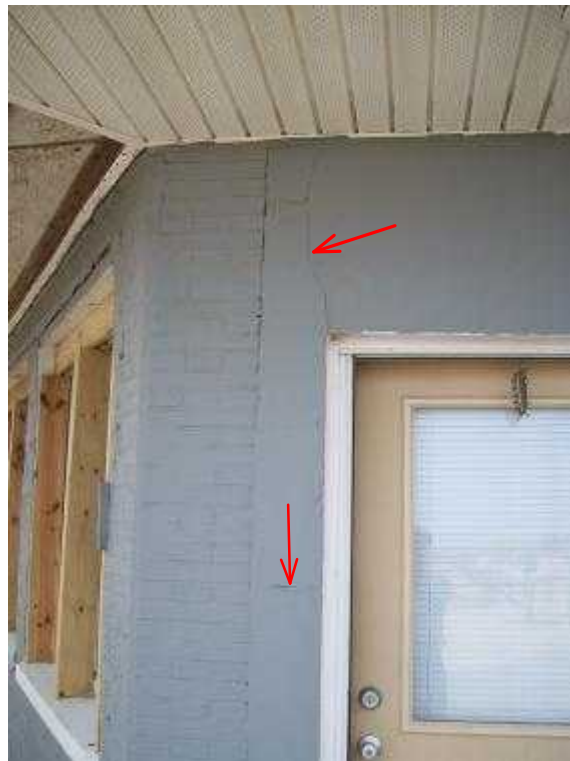
Walls were filled in between piers without expansion process causing stress cracks.

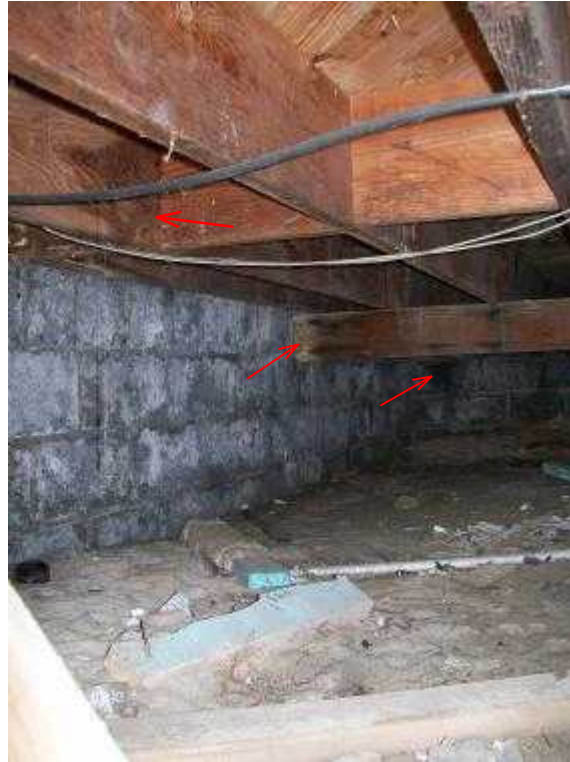
Main beam undersized dry rotted where it pockets into block wall with no additional support base. The beam is undersized for the live load of this building. Water staining on every component.
